The Fire Resistance Performance Of Six Specimens Of Wall Mounted And Six Specimens Of Floor Mounted Linear Gap Sealing Systems, Tested In Accordance With BS EN 1366-4: 2006

181967

**Everbuild Building Products**

1<sup>st</sup> May 2009

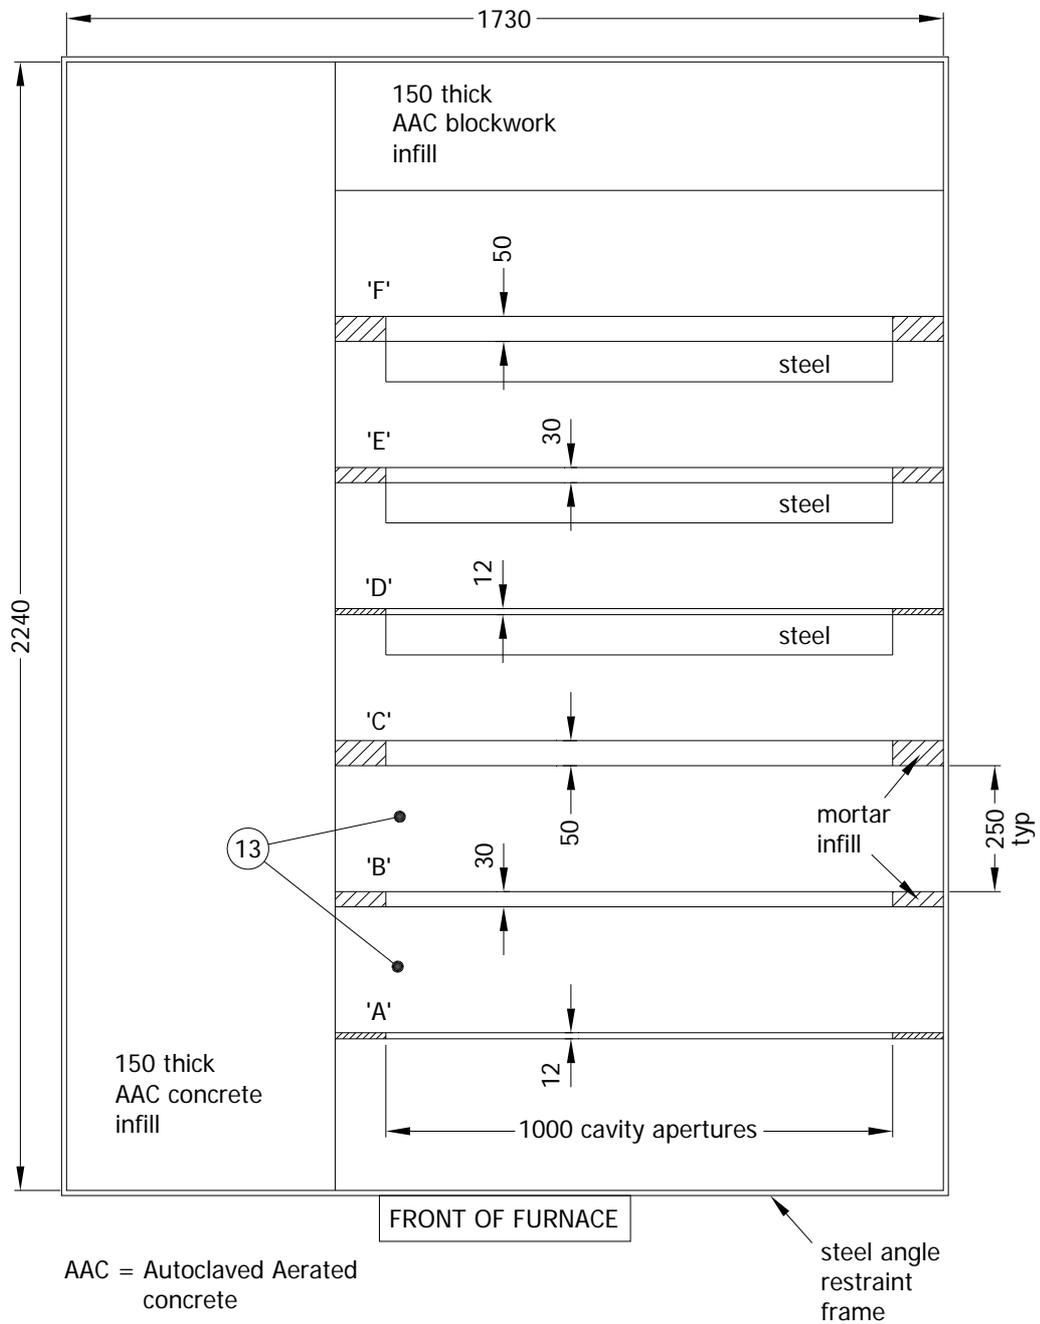
Figure 1- General Plan of Floor Test Specimens from Unexposed Face

The section of floor had overall dimensions of 2240 mm long by 1730 mm wide by 150 mm thick and was made up of autoclaved aerated concrete lintels arranged to provide two 12 mm wide by 1000 mm long, two 30 mm wide by 1000 mm long and two 50 mm wide by 1000 mm long linear gaps.

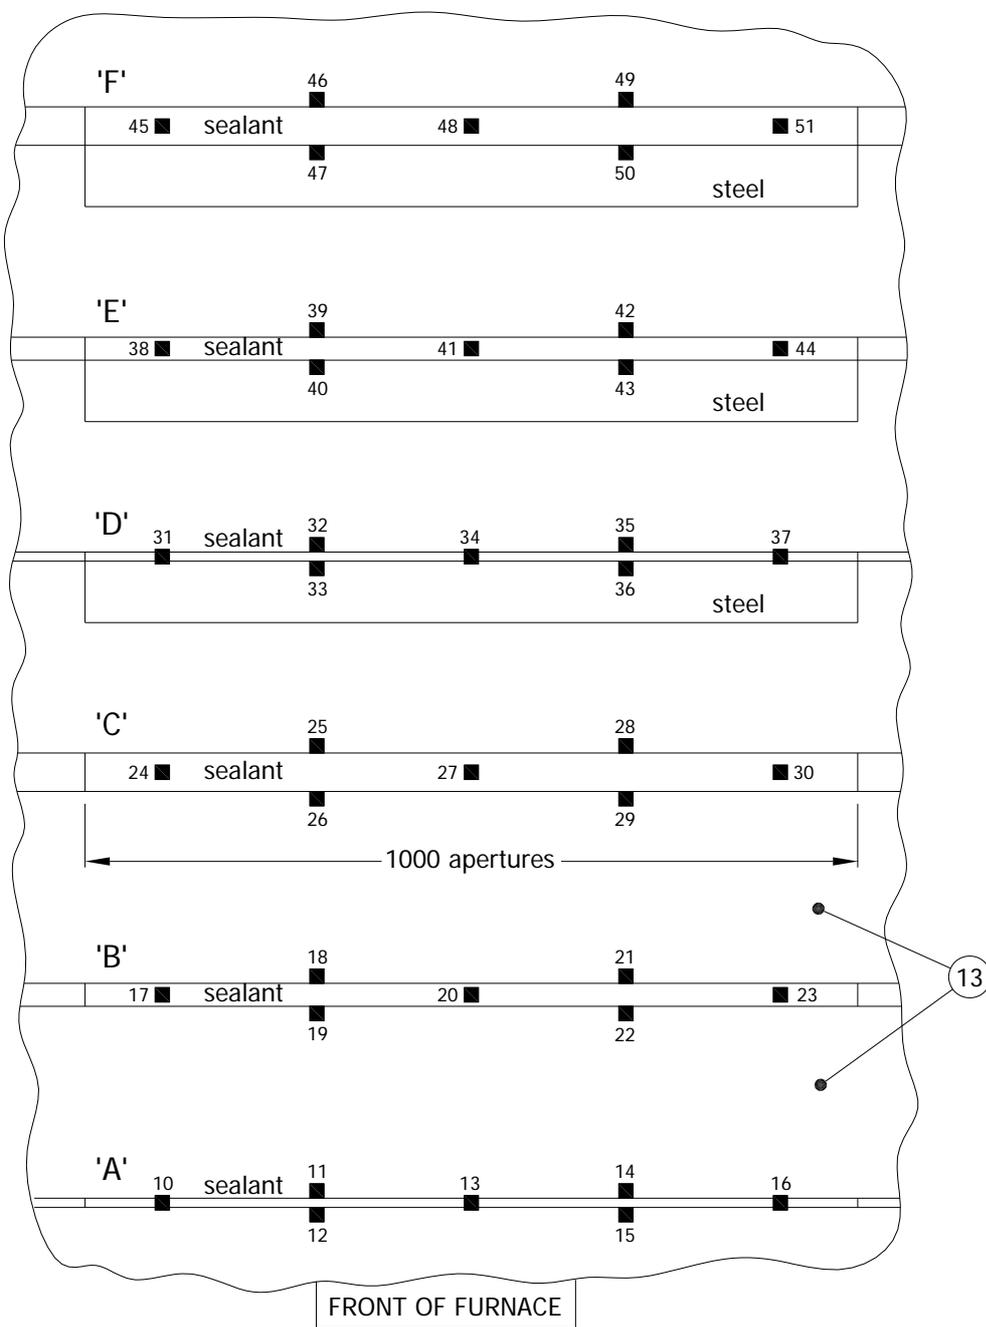
**Figure 2 – Enlarged View showing Unexposed Face Thermocouples for Floor Test Specimens**

■ Positions of thermocouples

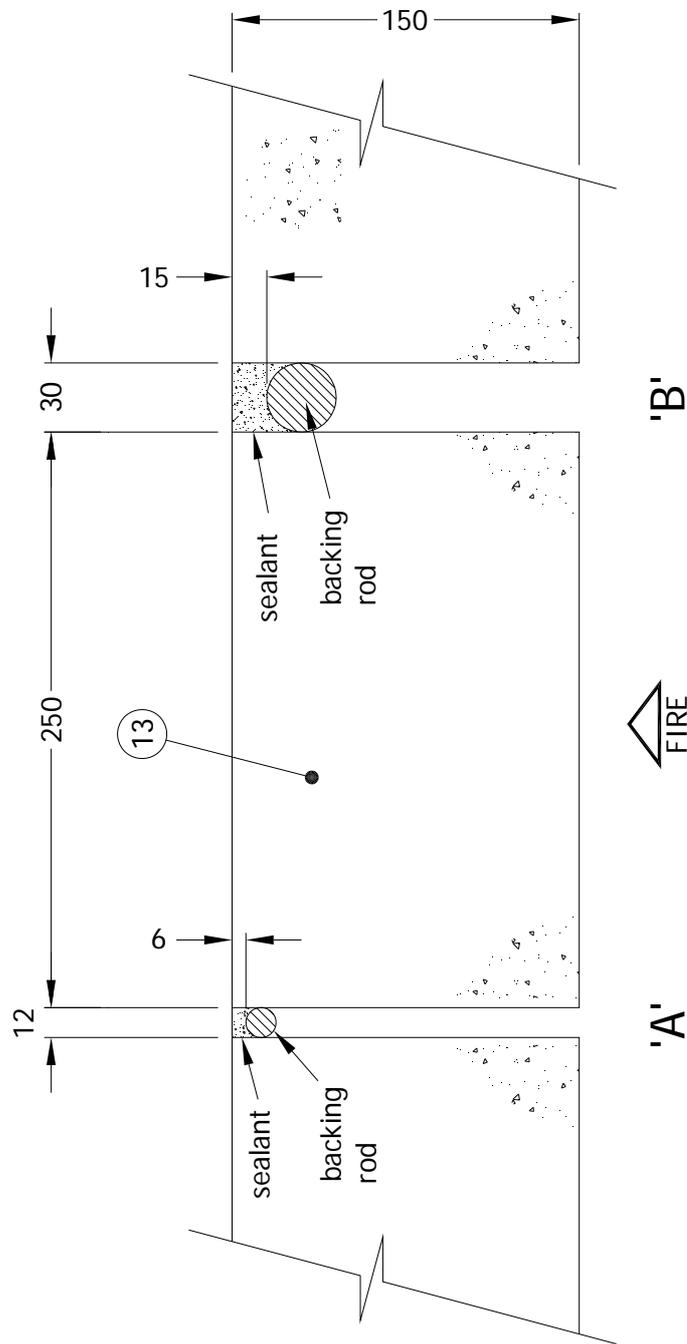
Figure 3 – Section Through Floor Specimens 'A' and 'B' (items 1 and 2)

<u>Item</u>	<u>Description</u>
<b>Details of Floor Joint Seals (items 1 to 6)</b>	
<b>1. Specimen 'A'</b>	
Details of Sealant	
Manufacturer	: Everbuild
Reference	: Firemate/AC95/Fireseal 300/LV intumescent
Material	: Acrylic Sealant
Overall section size of sealant	: 12 mm wide x 6 mm deep x 1000 mm long
Application method	: Cartridge gunned at unexposed face of cavity
Overall size of cavity	: 12 mm wide x 150 mm deep x 1000 mm long
Details of Backing rod	
Material	: Polyethylene
Size	: 13 mm diameter
Fixing method	: Friction fit within cavity
Details of Gap facing	: Masonry (item 13)
<b>2. Specimen 'B'</b>	
Details of Sealant	
Manufacturer	: Everbuild
Reference	: Firemate/AC95/Fireseal 300/LV intumescent
Material	: Acrylic Sealant
Overall section size of sealant	: 30 mm wide x 15 mm deep x 1000 mm long
Application method	: Cartridge gunned at unexposed face of cavity
Overall size of cavity	: 30 mm wide x 150 mm deep x 1000 mm long

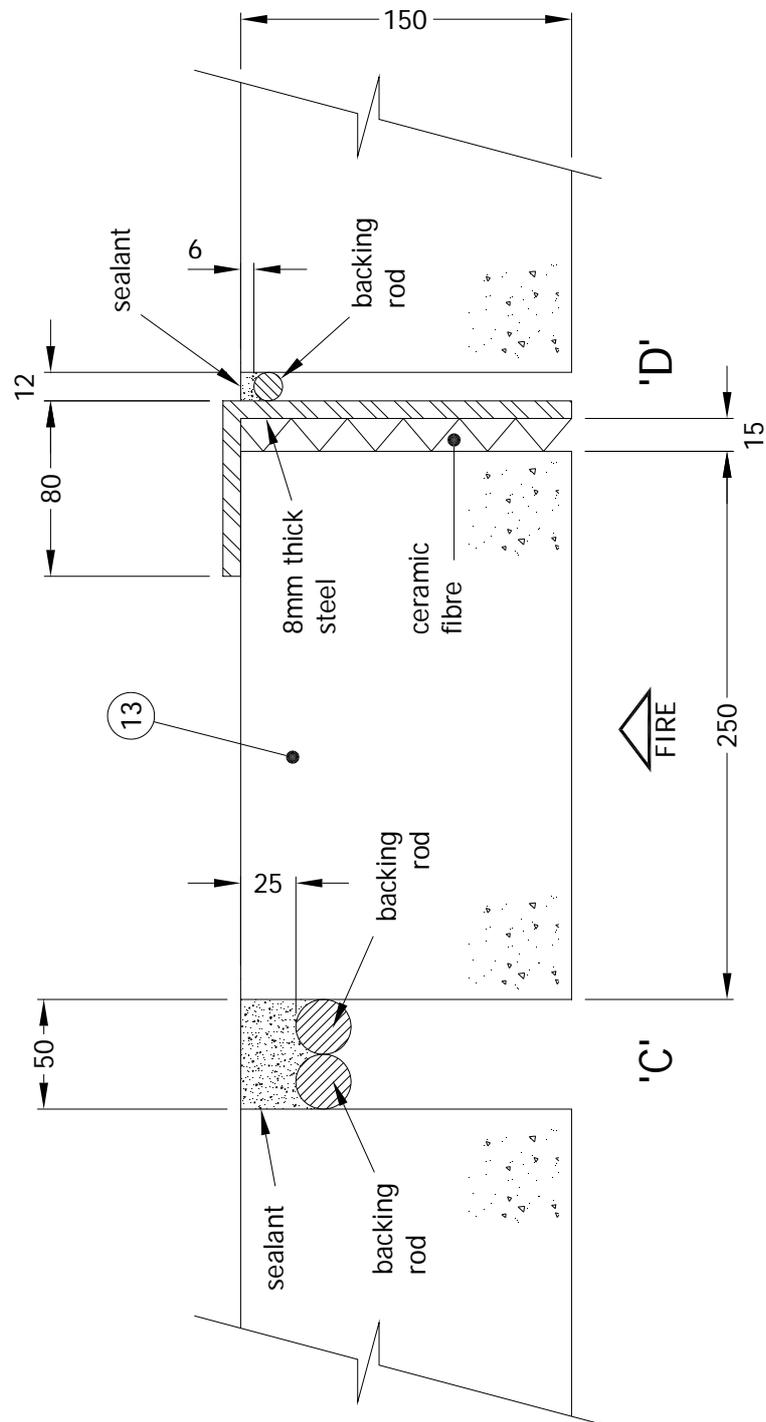
Figure 4 – Section Through Floor Specimens 'C' and 'D' (items 3 and 4)

Details of Backing rod	
Material	: Polyethylene
Size	: 30 mm diameter
Fixing method	: Friction fit within cavity
Details of Gap facing	: Masonry (item 13)
<b>3. Specimen 'C'</b>	
Details of Sealant	
Manufacturer	: Everbuild
Reference	: Firemate/AC95/Fireseal 300/LV intumescent
Material	: Acrylic Sealant
Overall section size of sealant	: 50 mm wide x 25 mm deep x 1000 mm long
Application method	: Cartridge gunned at unexposed face of cavity
Overall size of cavity	: 50 mm wide x 150 mm deep x 1000 mm long
Details of Backing rod	
Material	: Polyethylene
Size	: 2 no. rods, each 25 mm diameter
Fixing method	: Friction fit within cavity
Details of Gap facing	: Masonry (item 13)

<u>Item</u>	<u>Description</u>
<b>4. Specimen 'D'</b>	
Details of Sealant	
Manufacturer	: Everbuild
Reference	: Firemate/AC95/Fireseal 300/LV intumescent
Material	: Acrylic Sealant
Overall section size of sealant	: 12 mm wide x 6 mm deep x 1000 mm long
Application method	: Cartridge gunned at unexposed face of cavity
Overall size of cavity	: 12 mm wide x 150 mm deep x 1000 mm long
Details of Backing rod	
Material	: Polyethylene
Size	: 13 mm diameter
Fixing method	: Friction fit within cavity
Details of Gap facing	
Details of steel	
Thickness	: 8 mm
Fixing method to masonry	: 3 no. 5.5 mm diameter x 75 mm long screws
Details of insulation infill	
Material	: Ceramic fibre insulation
Fixing method	: Friction fit within void behind steel facing. See Figure 4.
<b>5. Specimen 'E'</b>	
Details of Sealant	
Manufacturer	: Everbuild
Reference	: Firemate/AC95/Fireseal 300/LV intumescent
Material	: Acrylic Sealant
Overall section size of sealant	: 30 mm wide x 15 mm deep x 1000 mm long

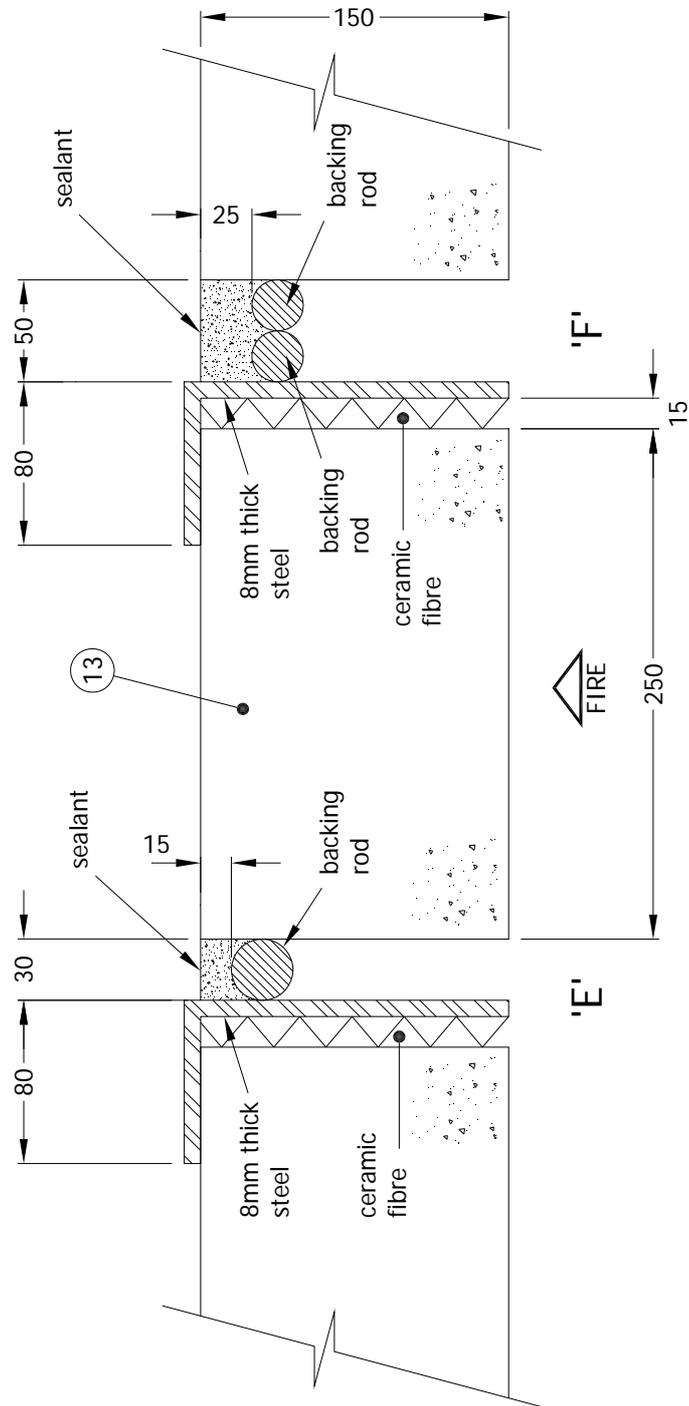
Figure 5 – Section Through Floor Specimens 'E' and 'F' (items 5 and 6)

<b><u>Item</u></b>	<b><u>Description</u></b>
<b>6. continued</b>	
Fixing method	: Friction fit within cavity
Details of Gap facing	: Steel/Masonry (item 13)
Details of steel	
Thickness	: 8 mm
Fixing method to masonry	: 3 no. 5.5 mm diameter x 75 mm long screws
Details of insulation infill	
Material	: Ceramic fibre insulation
Fixing method	: Friction fit within void behind steel facing. See Figure 5.

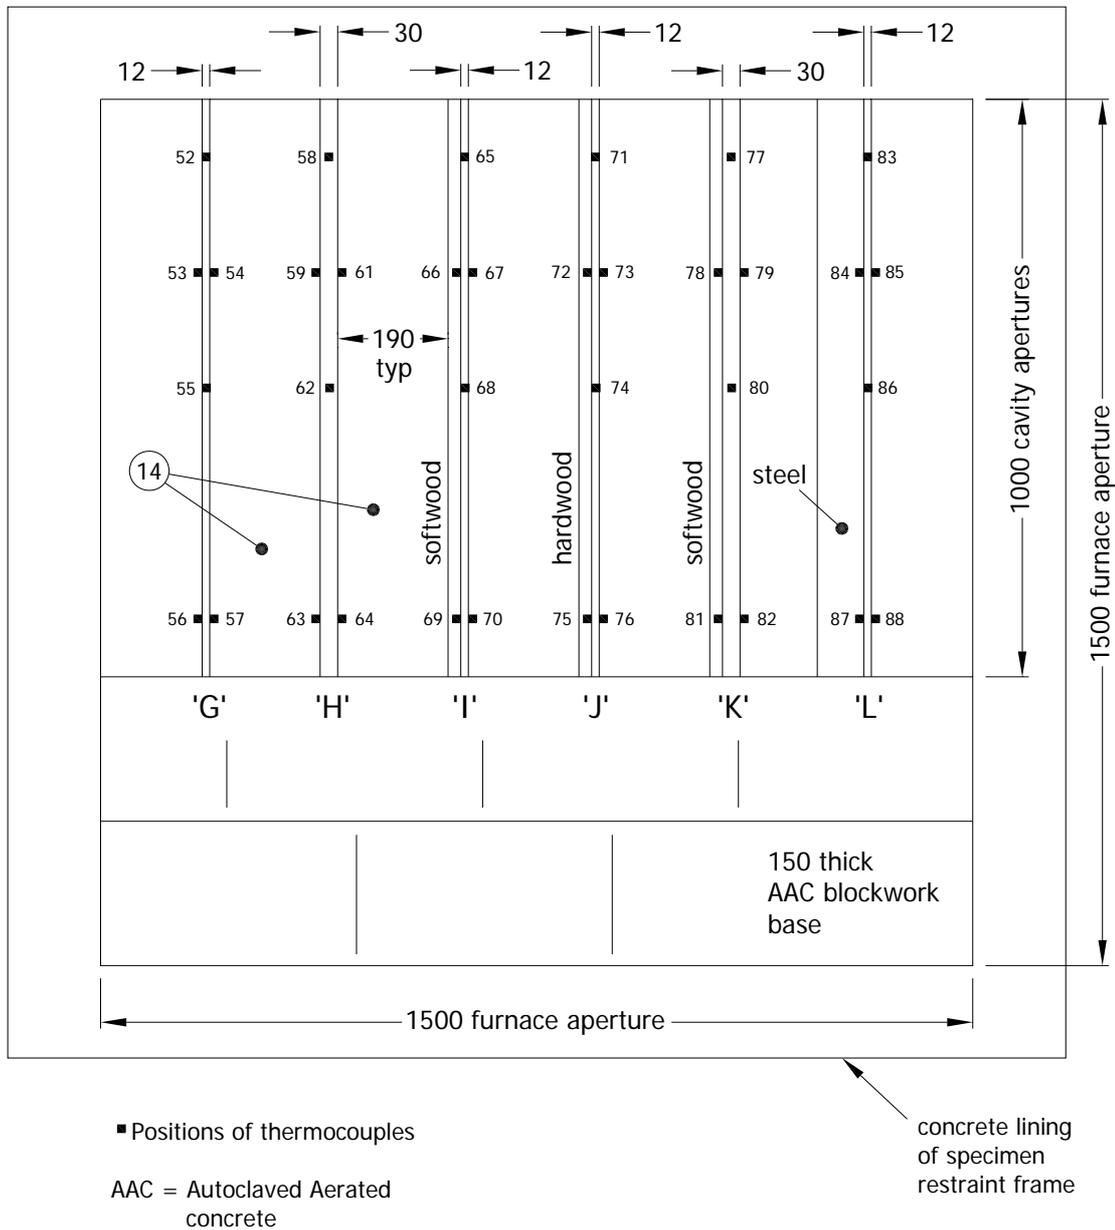
**Figure 6 – General Elevation of Wall Test Specimens and Thermocouples at Unexposed Face**

The section of wall had overall dimensions of 1500 mm high by 1500 mm wide by 150 mm thick and was made up of aerated blockwork arranged to provide four 12 mm wide by 1000 mm long and two 30 mm wide by 1000 mm long linear gaps.

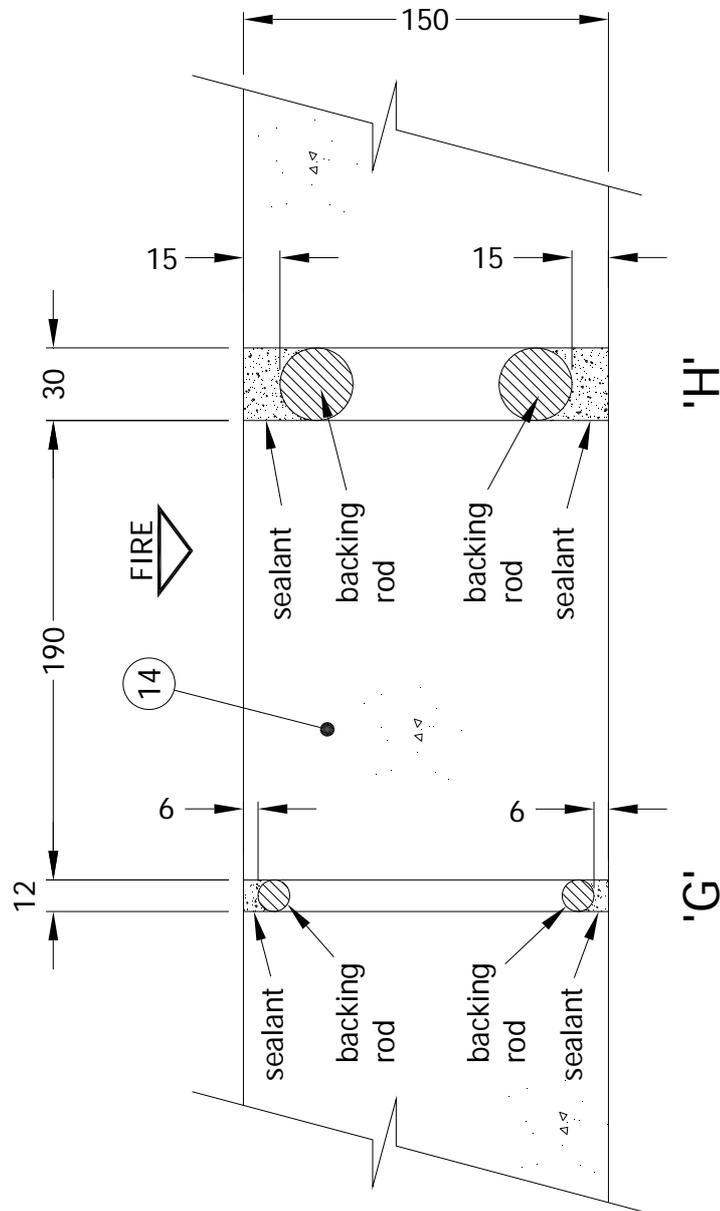
Figure 7 – Section Through Wall Specimens 'G' and 'H' (items 7 and 8)

Details of Sealant	
Manufacturer	: Everbuild
Reference	: Firemate/AC95/Fireseal 300/LV intumescent
Material	: Acrylic Sealant
Overall section size of sealant	: 12 mm wide x 6 mm deep x 1000 mm long
Application method	: Cartridge gunned at both faces of cavity
Overall size of cavity	: 12 mm wide x 150 mm deep x 1000 mm long
Details of Backing rod	
Material	: Polyethylene
Size	: 13 mm diameter
Fixing method	: Friction fit within cavity
Details of Gap facing	: Masonry (item 14)

Details of Sealant	
Manufacturer	: Everbuild
Reference	: Firemate/AC95/Fireseal 300/LV intumescent
Material	: Acrylic Sealant
Overall section size of sealant	: 30 mm wide x 15 mm deep x 1000 mm long
Application method	: Cartridge gunned at both faces of cavity
Overall size of cavity	: 30 mm wide x 150 mm deep x 1000 mm long
Details of Backing rod	
Material	: Polyethylene
Size	: 30 mm diameter
Fixing method	: Friction fit within cavity
Details of Gap facing	: Masonry (item 14)

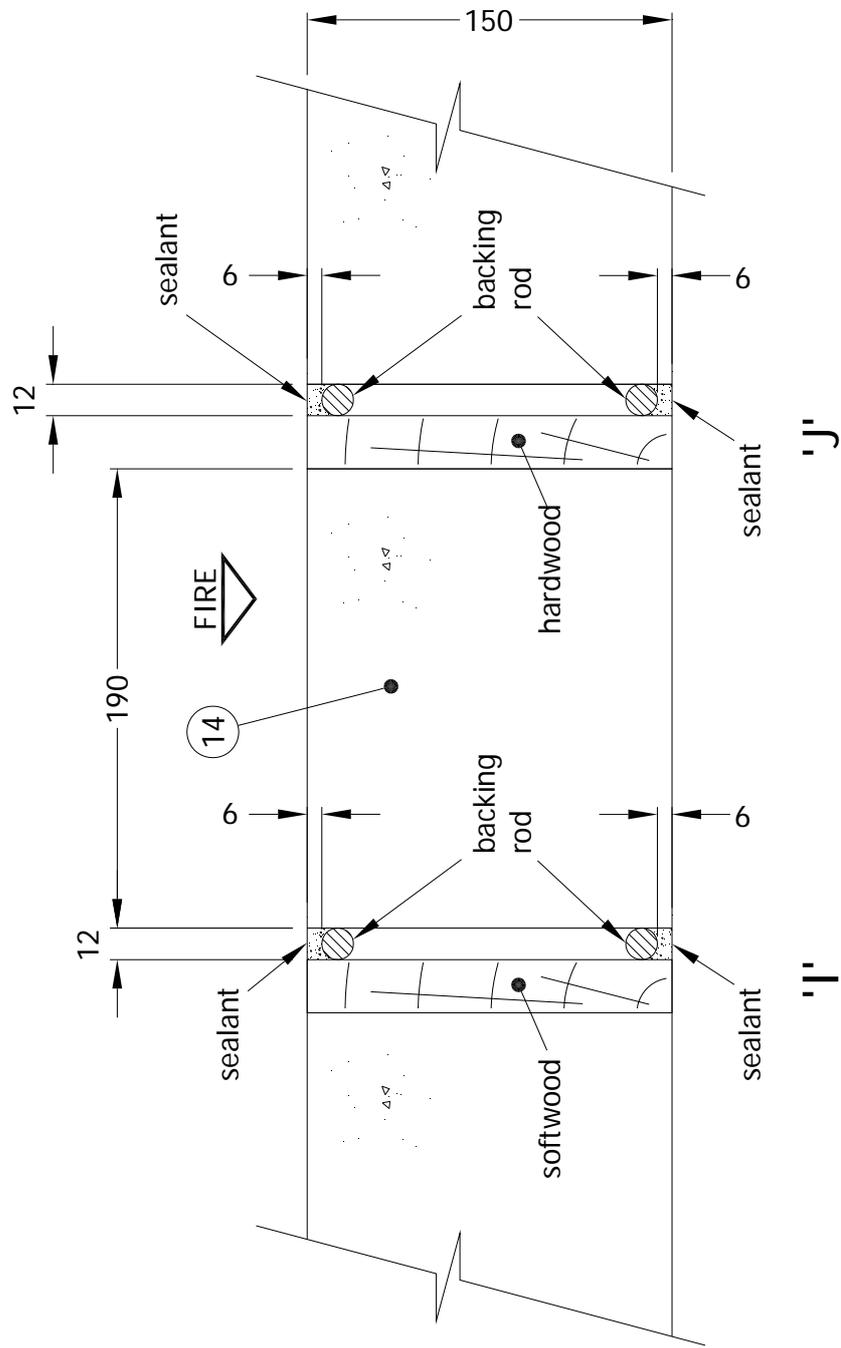
Figure 8 – Section Through Wall Specimens 'I' and 'J' (items 9 and 10)

Details of Sealant	
Manufacturer	: Everbuild
Reference	: Firemate/AC95/Fireseal 300/LV intumescent
Material	: Acrylic Sealant
Overall section size of sealant	: 12 mm wide x 6 mm deep x 1000 mm long
Application method	: Cartridge gunned at both faces of cavity
Overall size of cavity	: 12 mm wide x 150 mm deep x 1000 mm long
Details of Backing rod	
Material	: Polyethylene
Size	: 13 mm diameter
Fixing method	: Friction fit within cavity
Details of Gap facing	: Timber/Masonry (item 14)

<u>Item</u>	<u>Description</u>
<b>9. continued</b>	
Details of Timber	
Material	: Softwood
Thickness	: 22 mm
Fixing method to masonry	: 6 no. screws
<b>10. Specimen 'J'</b>	
Details of Sealant	
Manufacturer	: Everbuild
Reference	: Firemate/AC95/Fireseal 300/LV intumescent
Material	: Acrylic Sealant
Overall section size of sealant	: 12 mm wide x 6 mm deep x 1000 mm long
Application method	: Cartridge gunned at both faces of cavity
Overall size of cavity	: 12 mm wide x 150 mm deep x 1000 mm long
Details of Backing rod	
Material	: Polyethylene
Size	: 13 mm diameter
Fixing method	: Friction fit within cavity
Details of Gap facing	: Timber/Masonry (item 14)
Details of Timber	
Material	: Hardwood
Thickness	: 22 mm
Fixing method to masonry	: 6 no. screws
<b>11. Specimen 'K'</b>	
Details of Sealant	
Manufacturer	: Everbuild
Reference	: Firemate/AC95/Fireseal 300/LV intumescent
Material	: Acrylic Sealant
Overall section size of sealant	: 30 mm wide x 15 mm deep x 1000 mm long

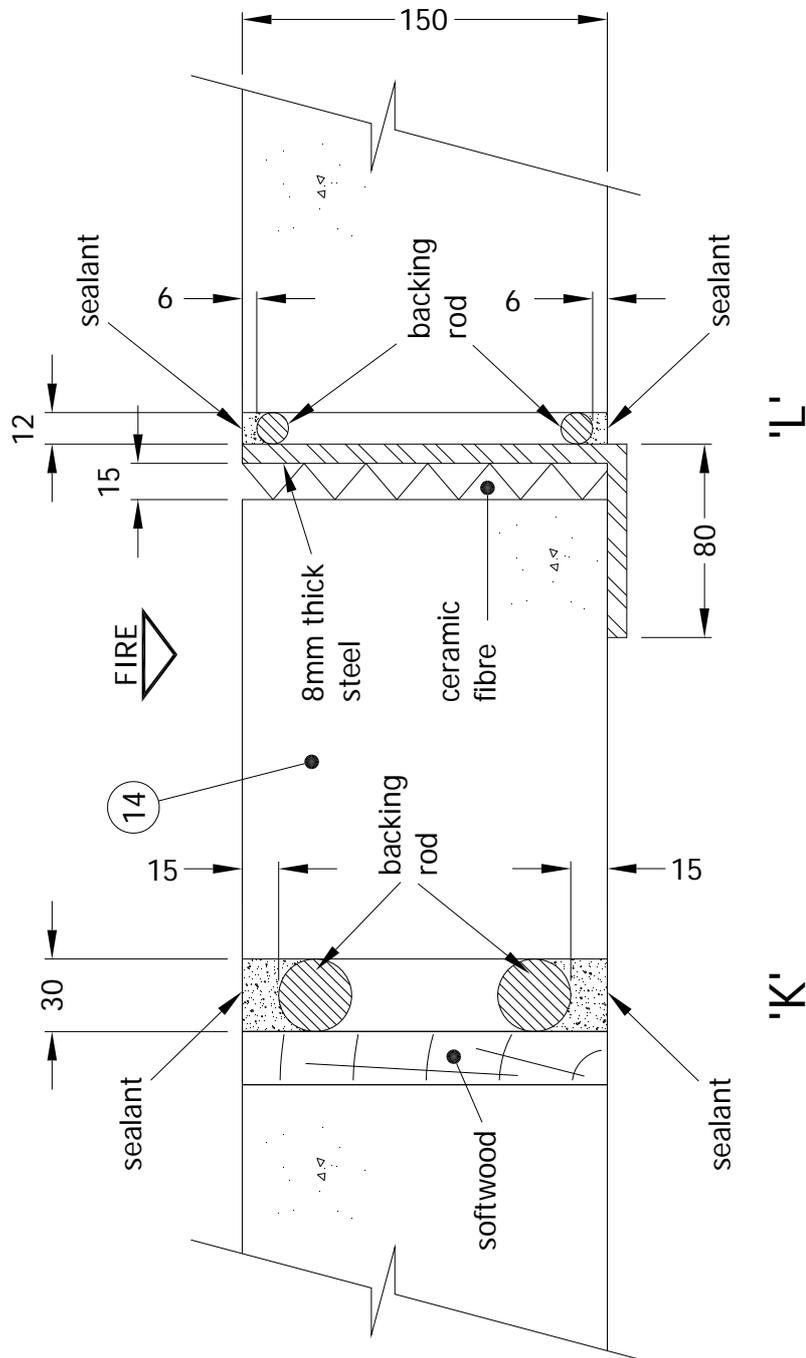
Figure 9 – Section Through Wall Specimens 'K' and 'L' (items 11 and 12)

<u>Item</u>	<u>Description</u>
<b>12. continued</b>	
Details of Backing rod	
Material	: Polyethylene
Size	: 13 mm diameter
Fixing method	: Friction fit within cavity
Details of Gap facing	: Steel/Masonry (item 14)
Details of steel	
Thickness	: 8 mm
Fixing method to masonry	: 3 no. 5.5 mm diameter x 75 mm long screws
Details of insulation infill	
Material	: Ceramic fibre insulation
Fixing method	: Friction fit within void behind steel facing. See Figure 9.
<b>13. Concrete Floor</b>	
Material	: Autoclaved aerated concrete lintels
Density	: 670 kg/m <sup>3</sup>
Thickness	: 150 mm
Bedding material	: Ordinary sand/cement mortar mix
<b>14. Blockwork Wall</b>	
Material	: Autoclaved aerated concrete blocks
Density	: 760 kg/m <sup>3</sup>
Thickness	: 150 mm
Bedding material	: Ordinary sand/cement mortar mix

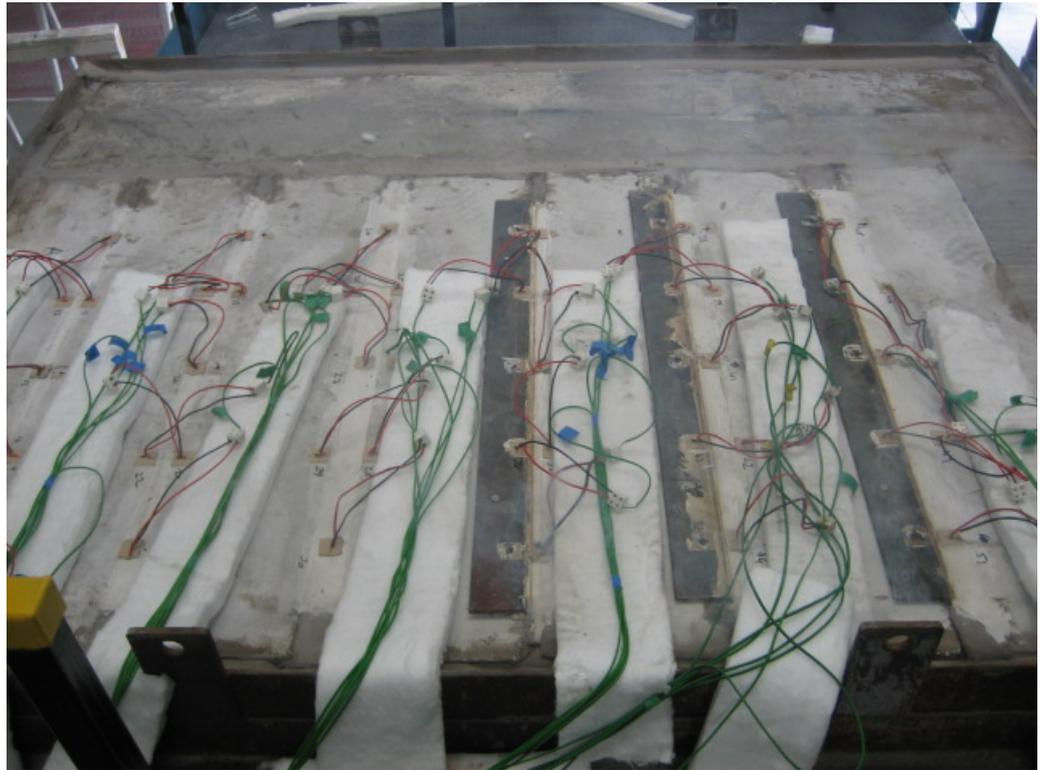
The unexposed  
face of the floor  
construction  
after 60 minutes  
of testing

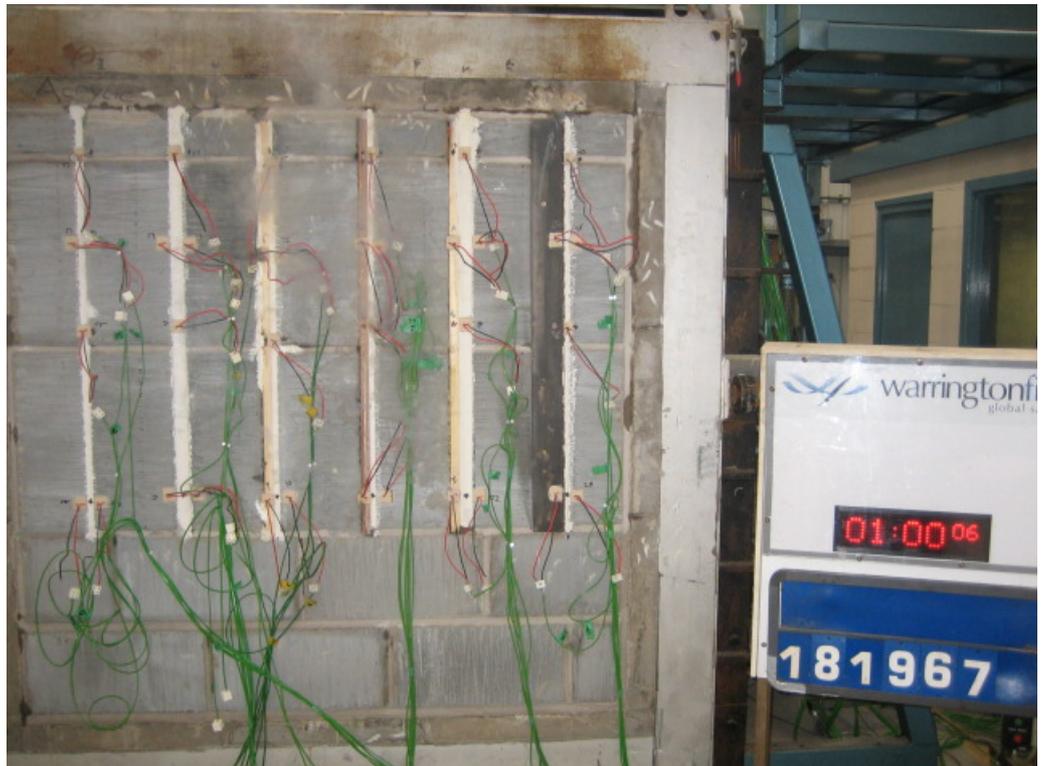
The unexposed  
face of the wall  
construction  
after 60 minutes  
of testing

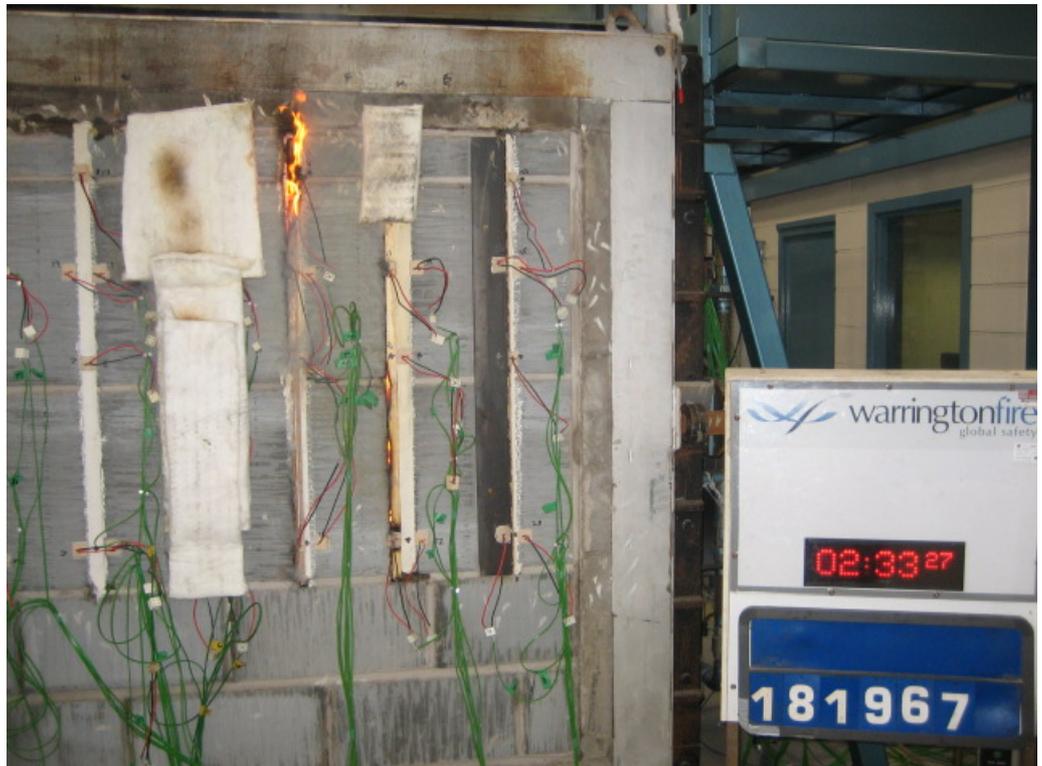
**The unexposed  
face of the wall  
construction  
after 153  
minutes of  
testing**

130	00	Brown discolouration spreads throughout the seals of Specimens B to F of the floor construction.
152	00	Thermocouple number 71 of Specimen J records a temperature rise in excess of 180° C. <b>Insulation failure of Specimen J is deemed to occur.</b>
153	00	A sustained flame is visible at the head of Specimen J as the timber substrate burns through and ignites. <b>Cotton pad and sustained flaming integrity failure of Specimen J is deemed to occur.</b> The specimen is blanked off to allow the test to continue.
164	00	Smoke release has reduced significantly from Specimens G to L.

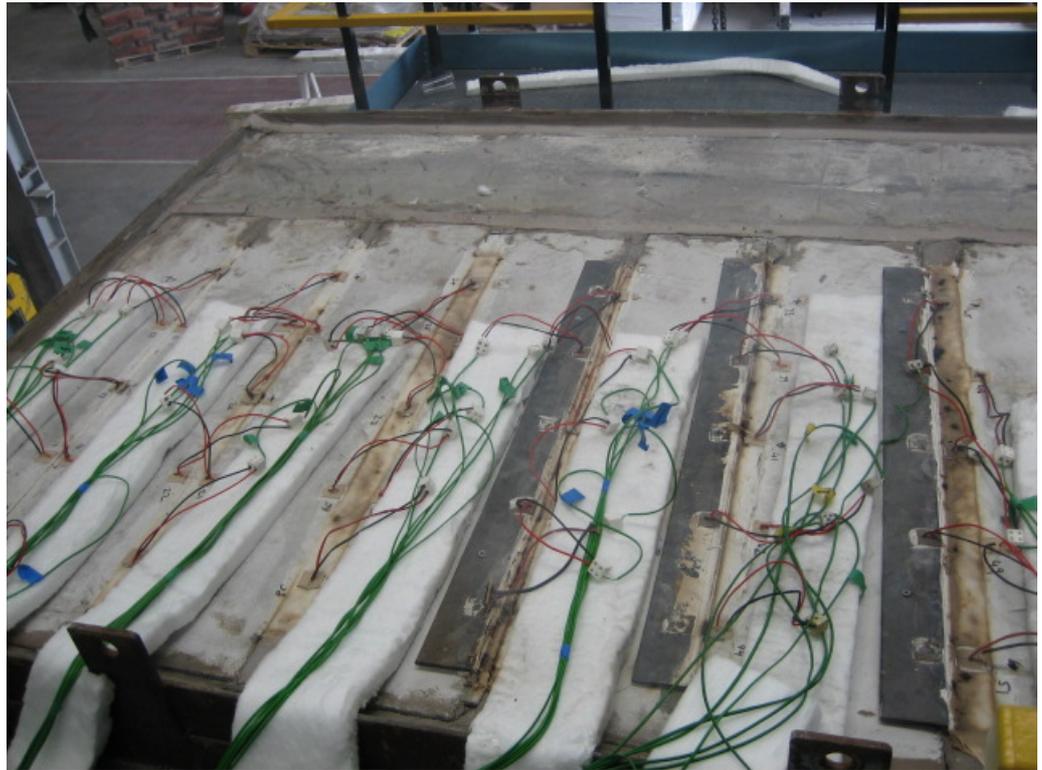
The unexposed face of the floor construction after 153 minutes of testing

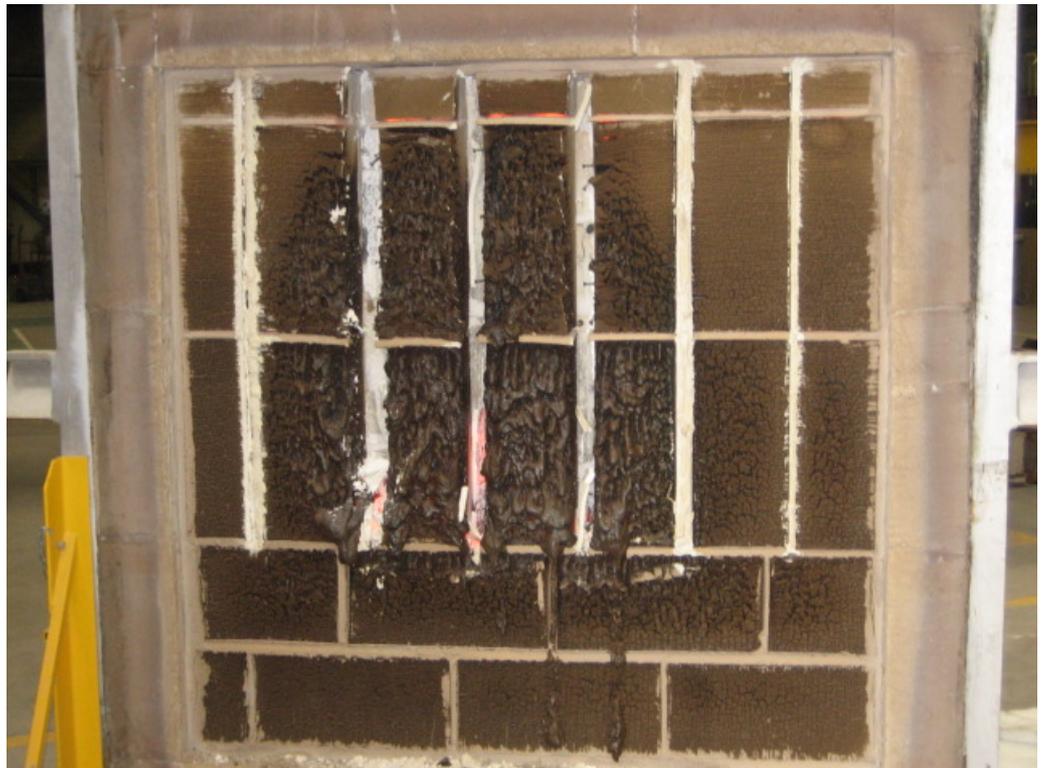
The exposed face of the wall construction immediately after testing

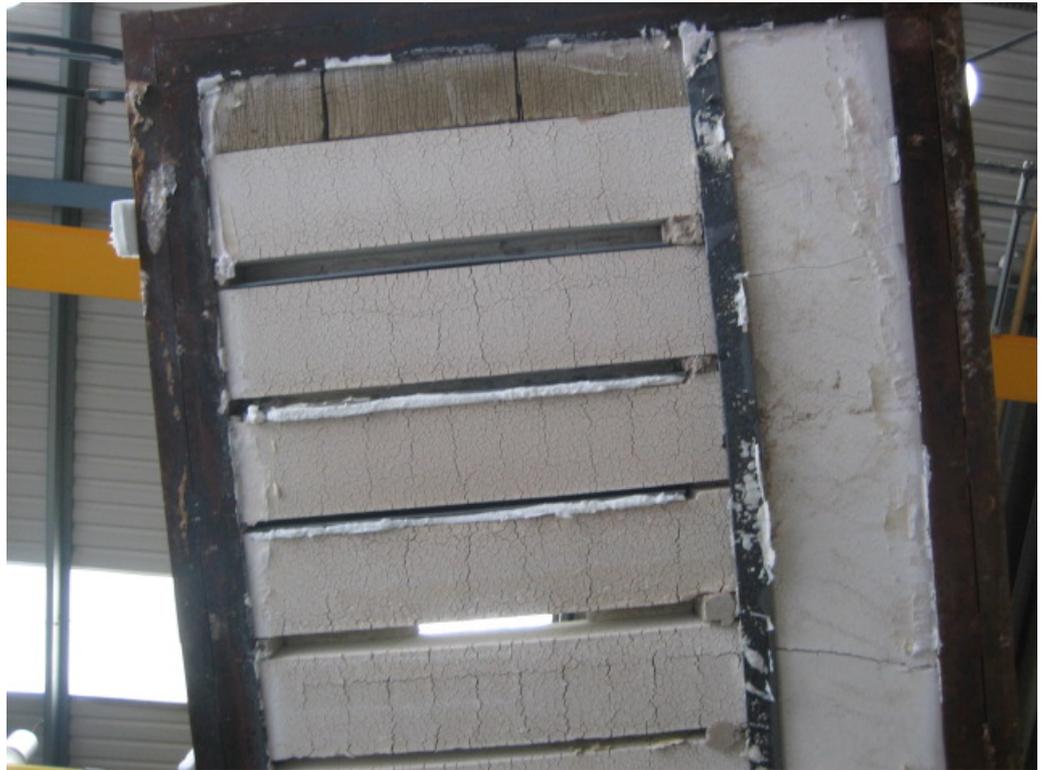
The exposed face  
of the floor  
construction  
after testing

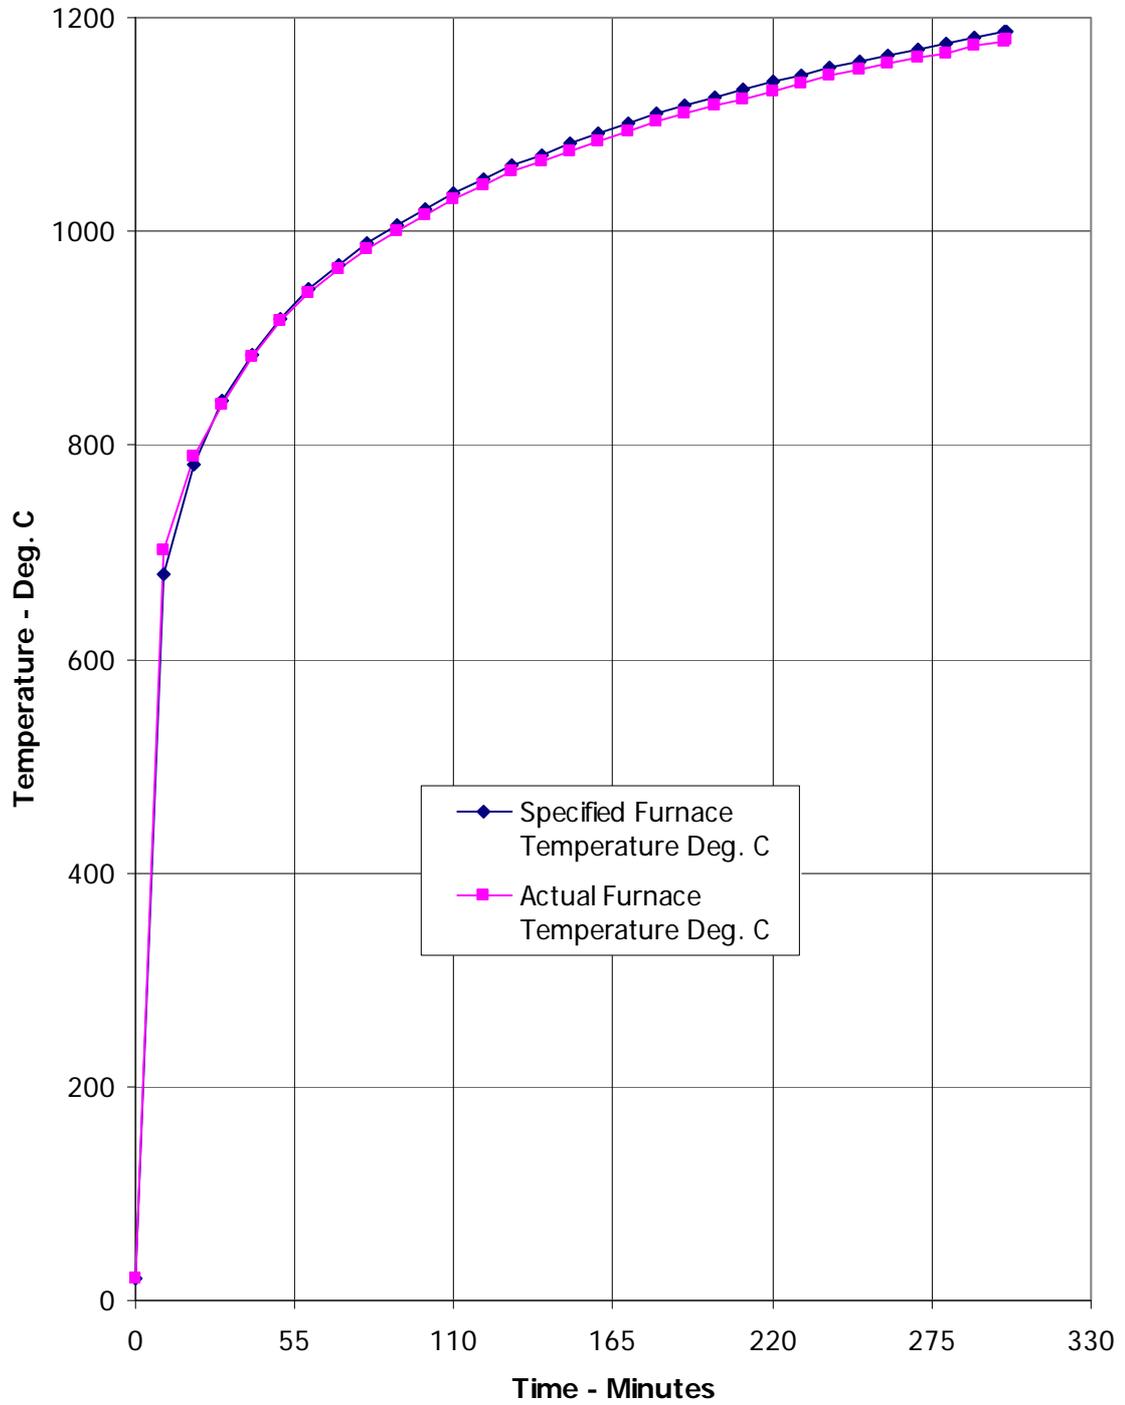
**Graph Showing Mean Furnace Temperature, Together With The Temperature/Time Relationship Specified In The Standard**

Time Mins	Specified Furnace Temperature Deg. C	Actual Furnace Temperature Deg. C
0	20	20
10	678	701
20	781	789
30	842	839
40	885	882
50	918	916
60	945	943
70	968	966
80	988	984
90	1006	1001
100	1022	1016
110	1036	1030
120	1049	1043
130	1061	1056
140	1072	1066
150	1082	1076
160	1092	1084
170	1101	1094
180	1110	1103
190	1118	1111
200	1126	1118
210	1133	1124
220	1140	1132
230	1146	1138
240	1153	1145
250	1159	1151
260	1165	1157
270	1170	1163
280	1176	1167
290	1181	1174
300	1186	1178
301	1187	1179
